Meeting House Roof – A Continuing Saga

David Newton,
Secretary Pro Tem
Building and Grounds
August 2018

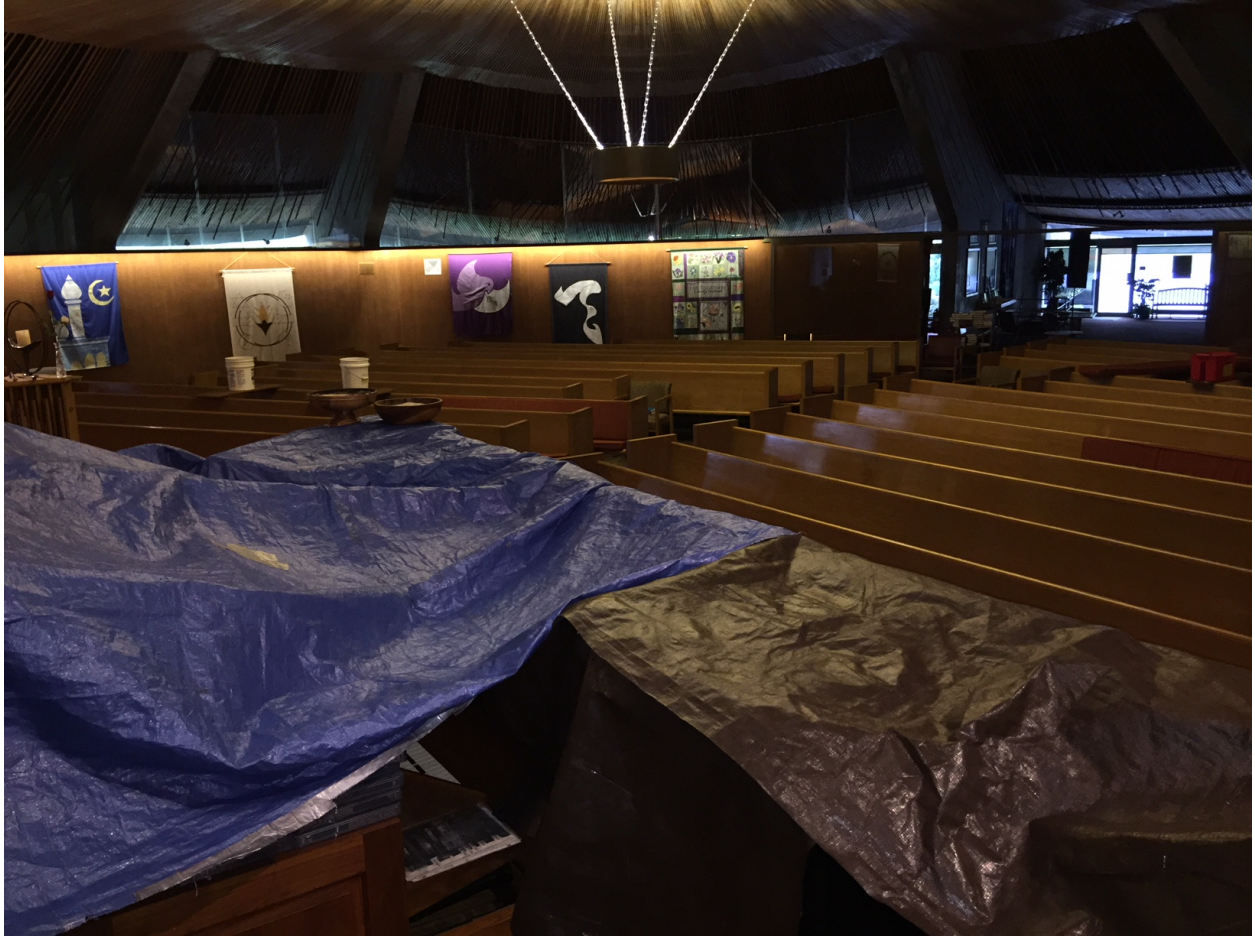
Periodically we have had rain, inside, and have even developed a common accessible storage of buckets, tarps and associated equipment. Our carpet and pew cushions were selected for indoor-outdoor capacity to withstand water without damage.

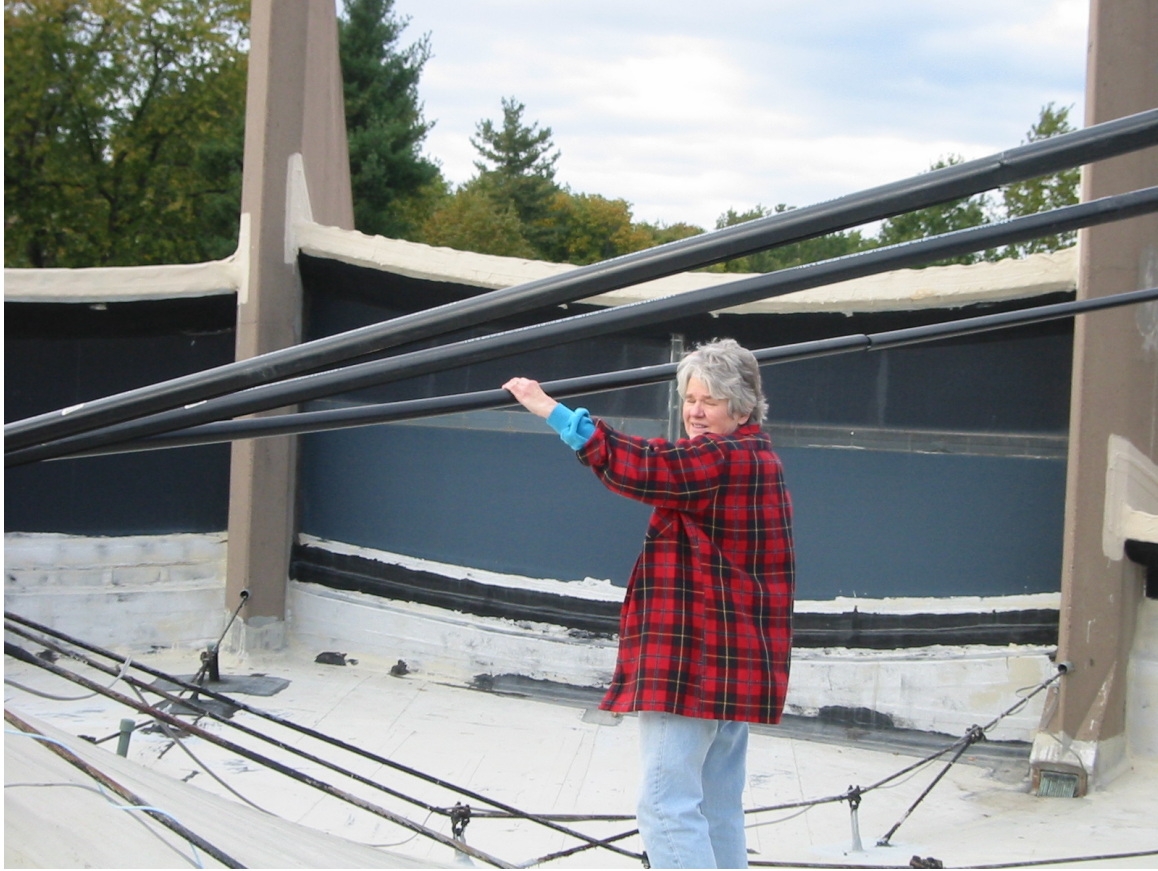
We discovered rain falling on the cables supporting the roof drained down into the support hub, and from there entered the Sanctuary, so we covered the cables in 2005, and that helped.

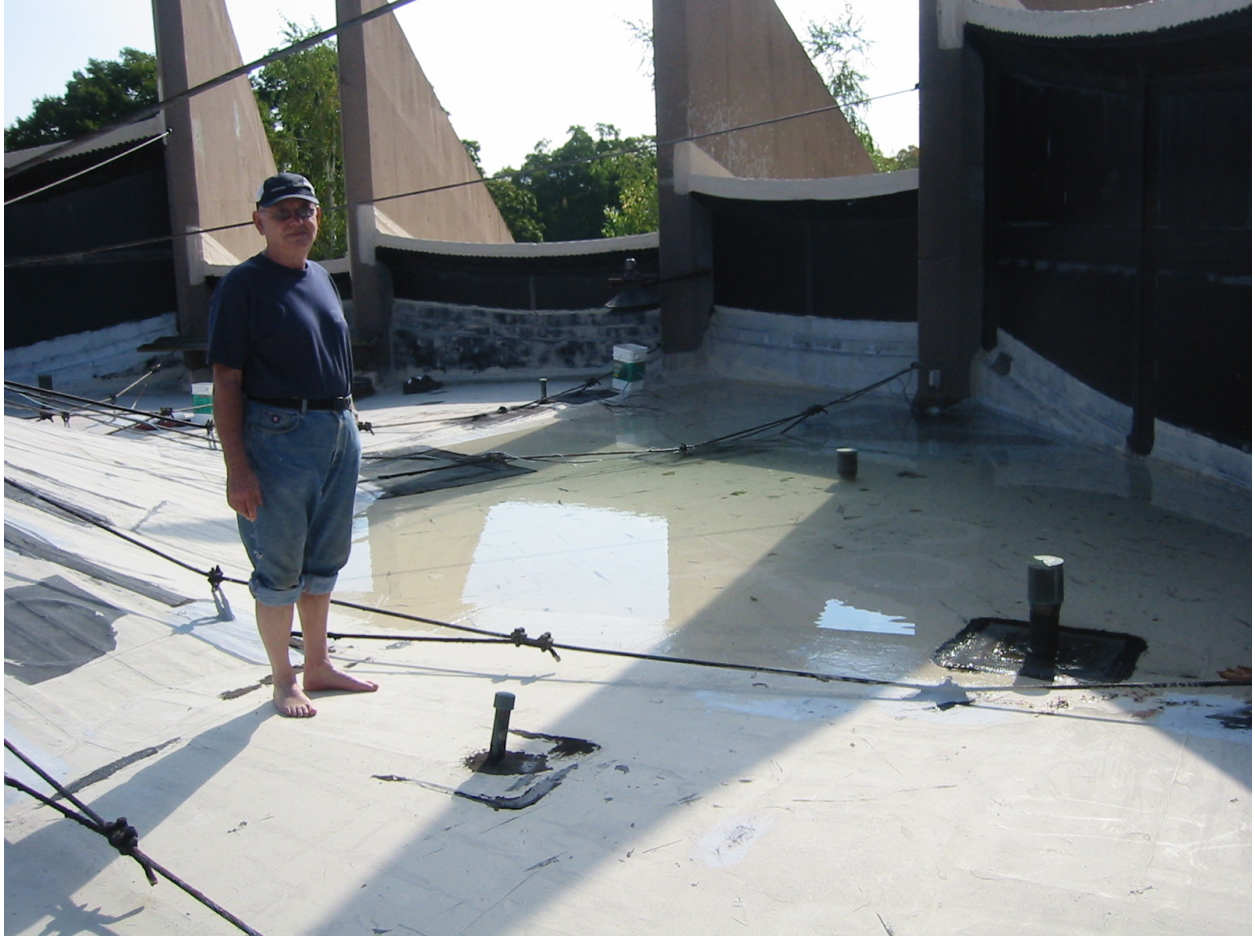
Ponding on the roof continued to be a problem because the drains needed to be improved and debris removal, freezing within, and such matters needed to be prevented. Here Stu prepares to enter the lake and open one of four drains. This particular drain was relined with hose to prevent the leak inside Servetus (October, 2005).

The Servetus wall leak was subsequently addressed by placing a plastic pipe inside the fractured pipe, and, adding roof heating cables to the inside of the drains above the roof line to prevent similar damage. This fixed actually worked! Few remaining members know the wet little secret about the Servetus wall. During this time B and G also learned cottonwood fluff would block the drains during May each year causing serious leaking as water ponded on the roof causing pressure. Ultimately the water found holes ending up in the Sanctuary.

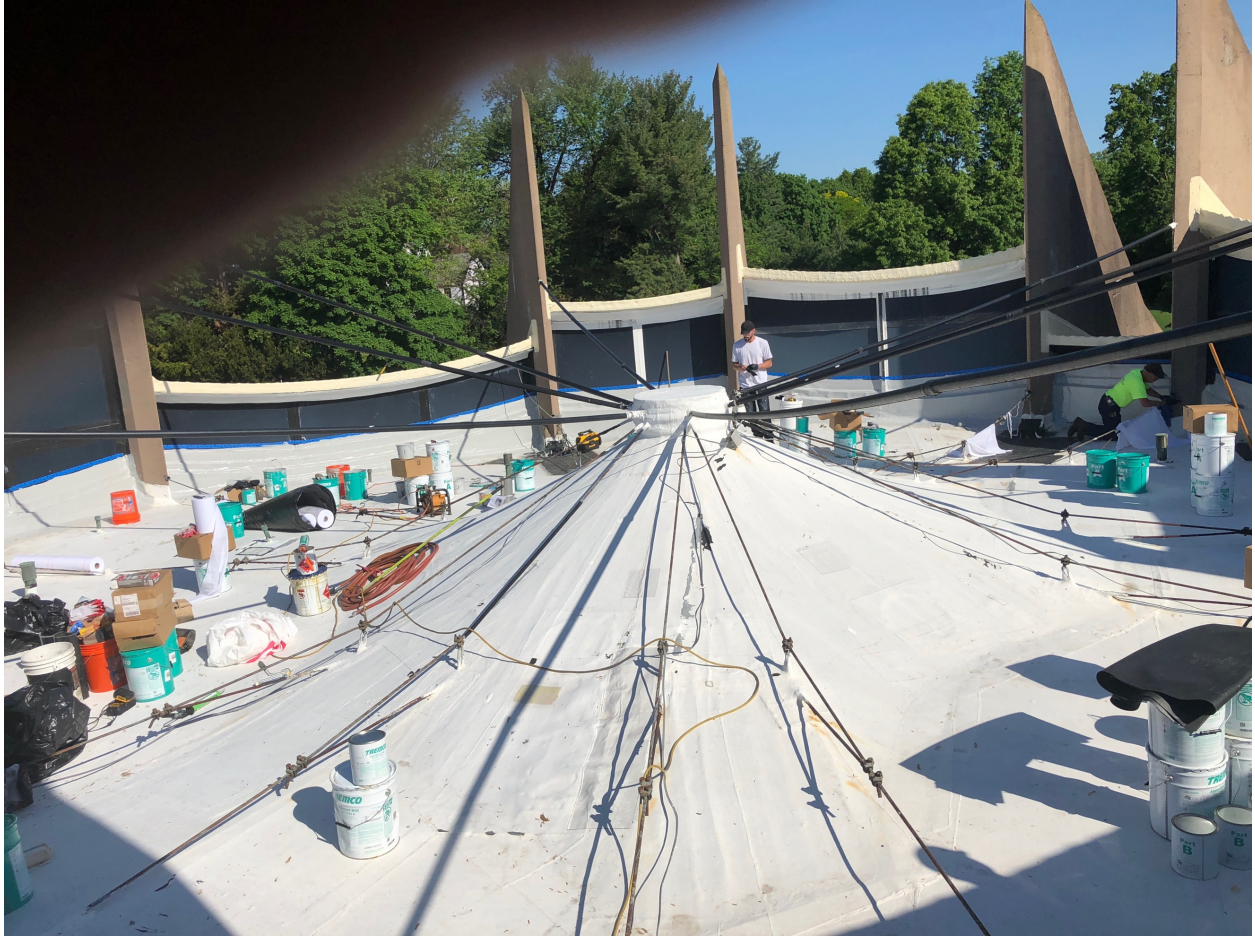
In 2018 a new methodology was employed to repair, recover and improve the roof. Here the contractor is surrounded by buckets of fluids and equipment used to apply a new tough membrane covering the entire roof (May 2018).

However, as more years passed, it became yet more difficult to suppress new leaks in spite of the diligent efforts of Sextons John Bengtson and Kevin Girouard, who spent many a rainy and snowy day on roof repair duty. Consequently, following the requisite preliminary steps guided by our Architect Member, Hugh Schweitzer, a contractor was identified from the Eagle Rivet Roof Service Corporation, who would actually take on the roof repair job. And, to the joy of all participants in the bid solicitation and subsequent planning, there was a new methodology available for doing so. After extensive cleaning and repair of the roof structure and drains, a fluid roofing system was applied. It is termed the Polyurethane Elastomeric Fluid Applied System consisting of a first coat, Tremco AlphaGuard BIO Base coat, and the second coat, Tremco

AlphaGuard B10 Top Coat. Together the two coats create a continuous tough membrane over the entire older roof EPDM.

No seams to split apart! The membrane manufacturer, Tremco, Inc., guarantees the resulting membrane for 20 years from the date of substantial completion, about now.

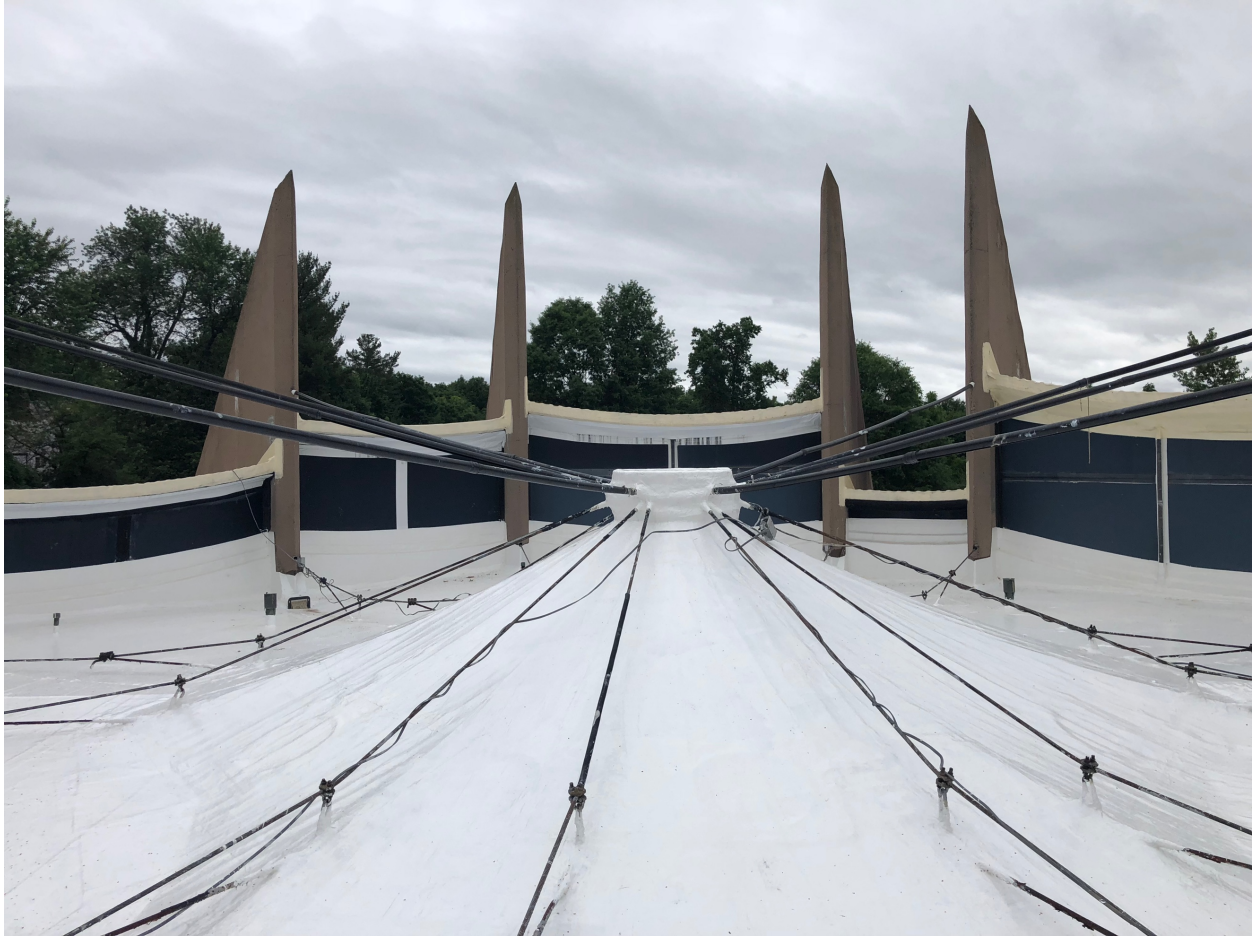
And, now, with the shiny new coating in place, we look forward to an improved situation. It rained with some enthusiasm recently, and there were no leaks! (July 2018)

We have just finished this project supported by an Endowment expenditure of \$40,775. Final inspection has been completed, and substantial rains have occurred with no known leaking. Continuing maintenance of the new drain filters will be necessary and careful operation of the drain heaters during winter will be required.
